SEE TAL LAKE DAM  
(Formerly Glennon Epple Dam)  
GASCONADE COUNTY, MISSOURI

MISSOURI INVENTORY NO. 30668

PHASE I INSPECTION REPORT  
NATIONAL DAM SAFETY PROGRAM

PREPARED FOR  
ST. LOUIS DISTRICT, CORPS OF ENGINEERS  
NOVEMBER, 1978

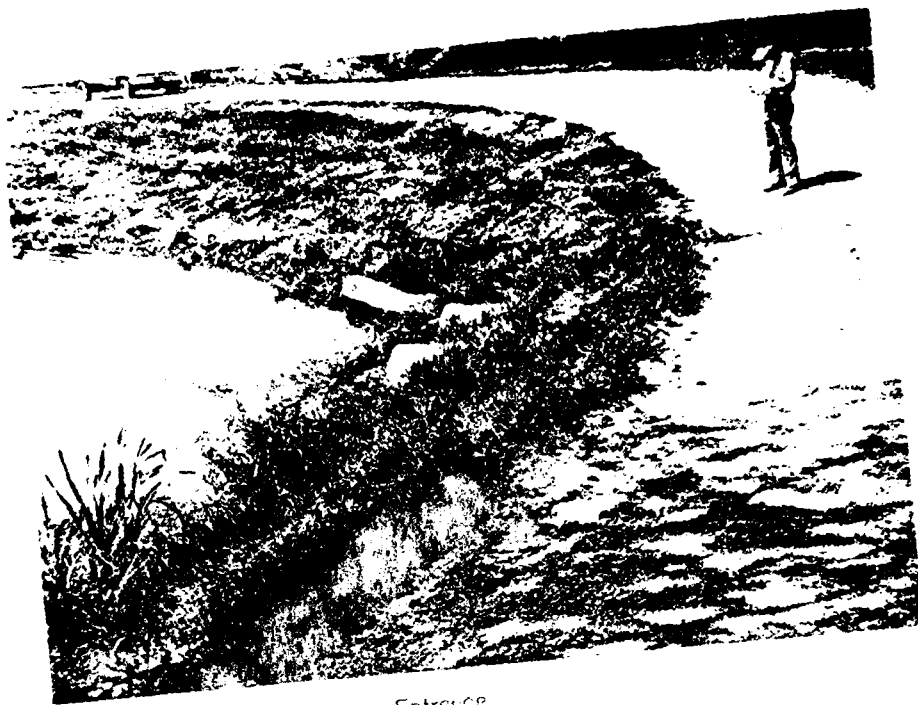
PHOTO 3 Spillway Entrance
